This spreadsheet performs screening level calculations to estimate the effect of peeling leaded paint on the average concentration of lead in yard soil
3316 Lafayette Street

LBP Assessment Results

Strat Environmental Resource

Property ID # 156 / 3316 Lafayette

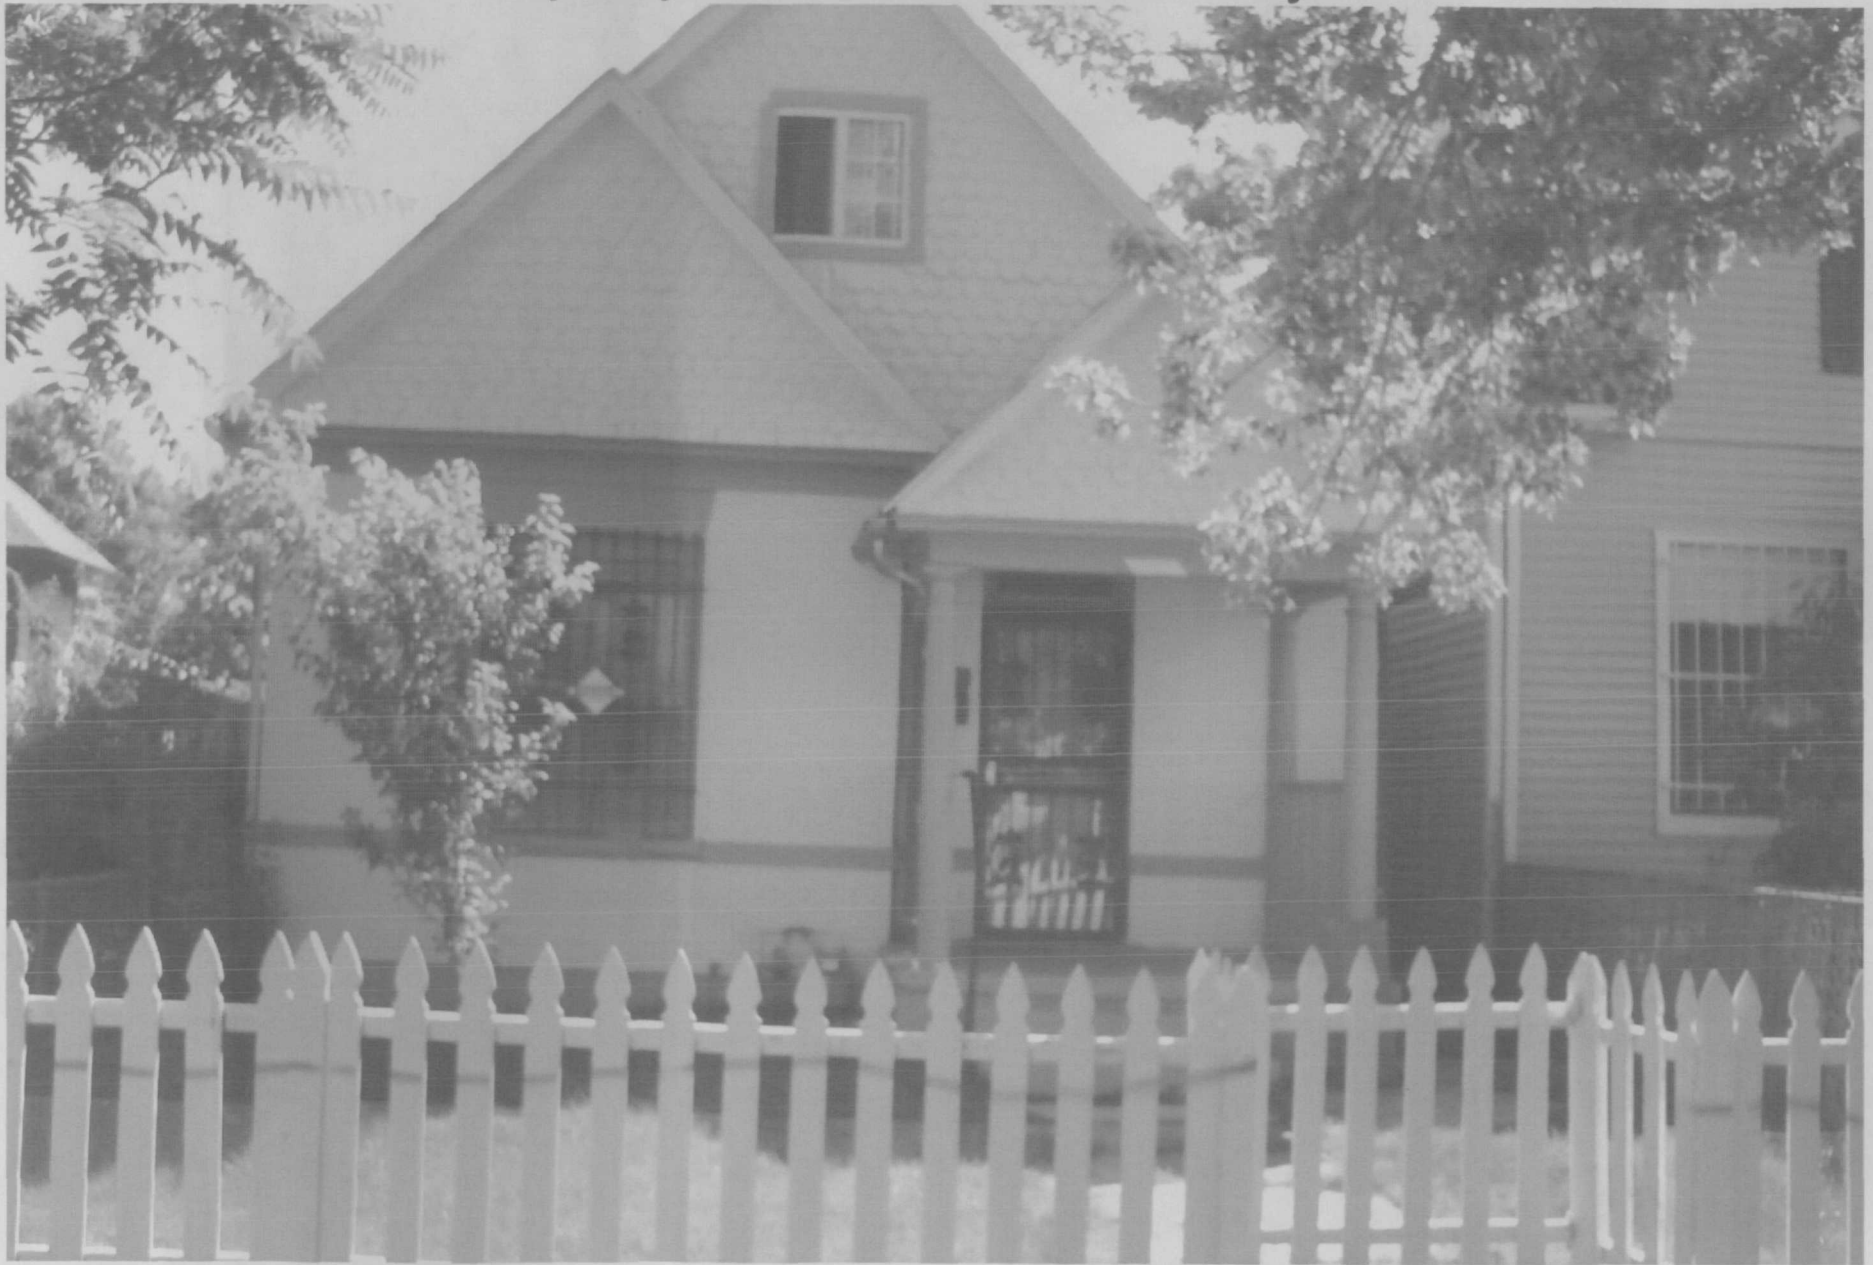
Majority of house does not contain lead paint
